PHYSICAL RESEARCH REPORT NO. 66

INVESTIGATION OF
BRIDGE APPROACH SPANS TO
POPLAR STREET BRIDGE

A Preliminary Study

Floyd K. Jacobsen, Bridge Research Engineer

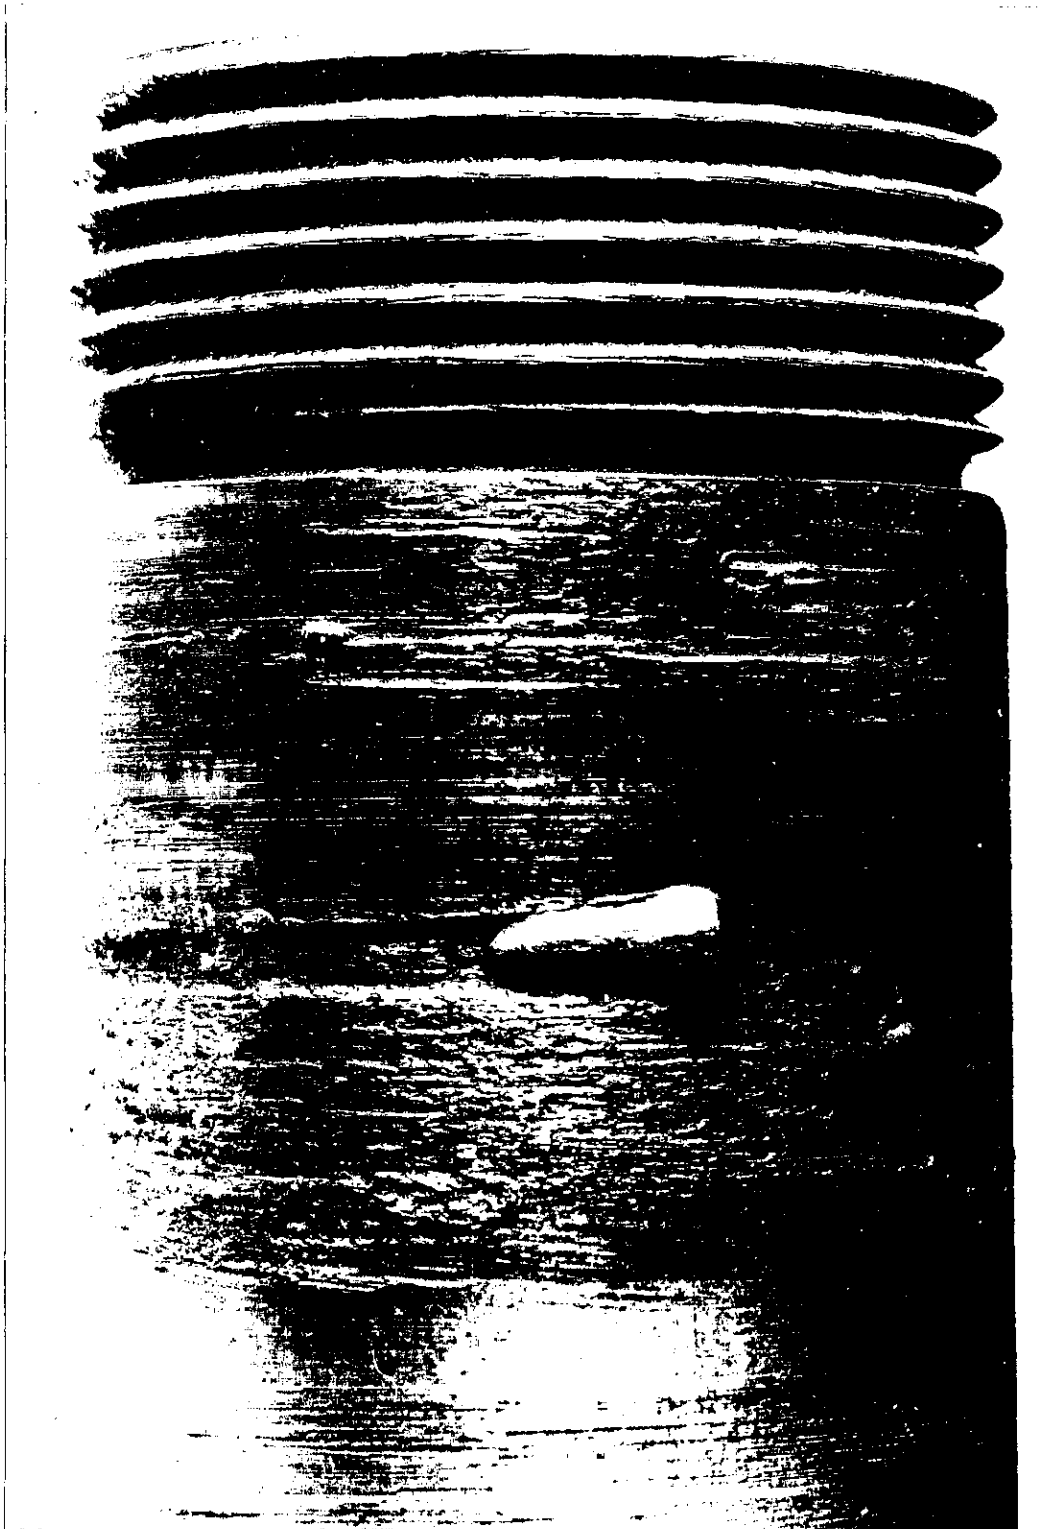
horizontal force required to rotate the bearing. Examination of the pin after completing the test had revealed evidence of galling on both the pin and the saddle as shown in Figure 7 and 8. The galling had produced a build-up of hard, solid material which had a tendency to lock the pin to the supporting saddle.

Figure 7. Pin of 1/3 size model bearing showing evidence of galling.

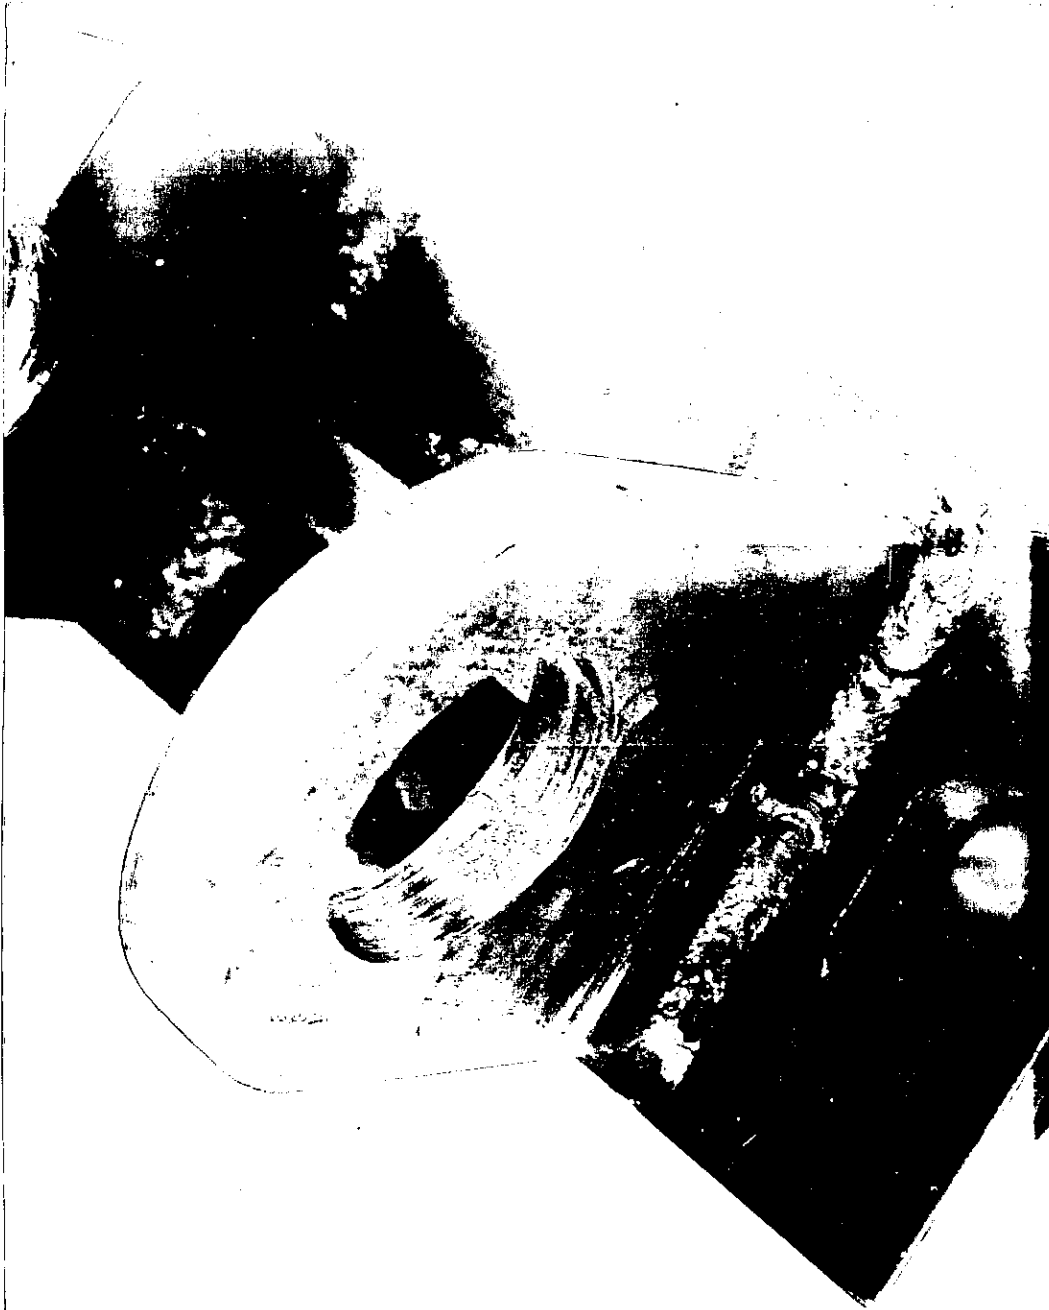
Figure 8. Saddle of 1/3 size model bearing showing evidence of galling.

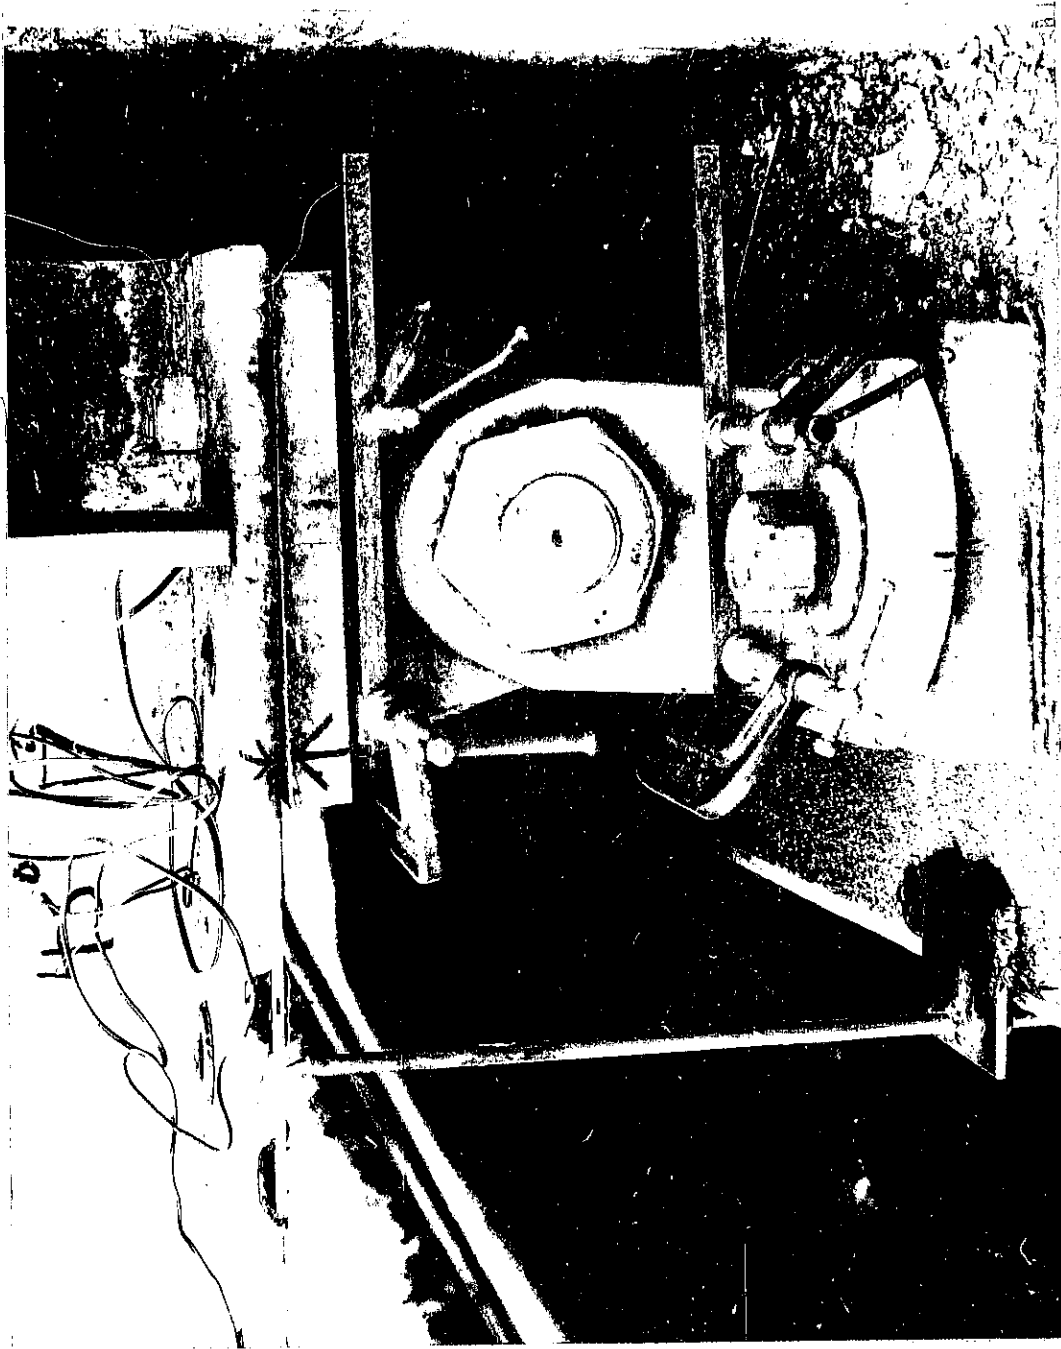
On the basis of the laboratory tests, it appeared that the effect of loading and the angle of orientation may not have been major factors contributing to the seizure of the bearings. The seized bearing from Ramp B at the east abutment was removed and replaced to determine if there were other factors related to the seizure (Figure 12). The bearing on the opposite side also was replaced so that thermal movements at the east end of the structure could be monitored.

Figure 12. Pin connected steel bearing assembly before removal from structure.

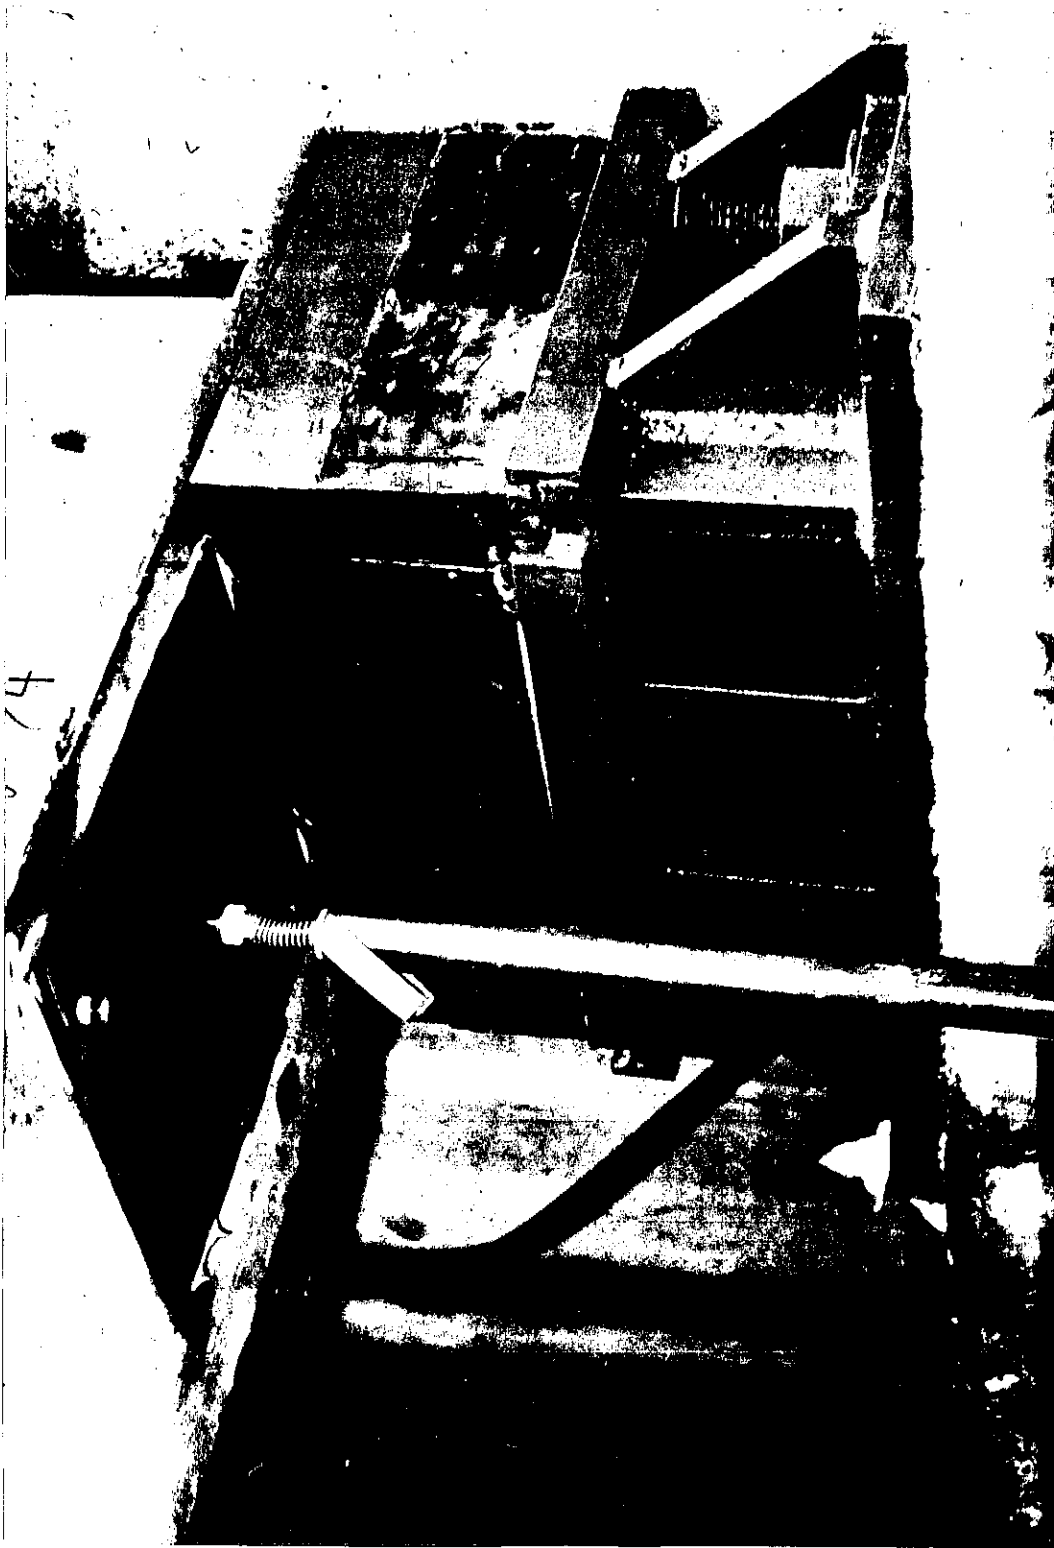
Figure 13. Experimental elastomeric bearing and instrumentation for detecting thermo movements.

The bearings used for replacing the steel bearing assemblies were elastomeric bearings reinforced with steel laminates. The overall dimensions of the bearings were 12 in. x 18 in. x 5 in. (Figure 13).

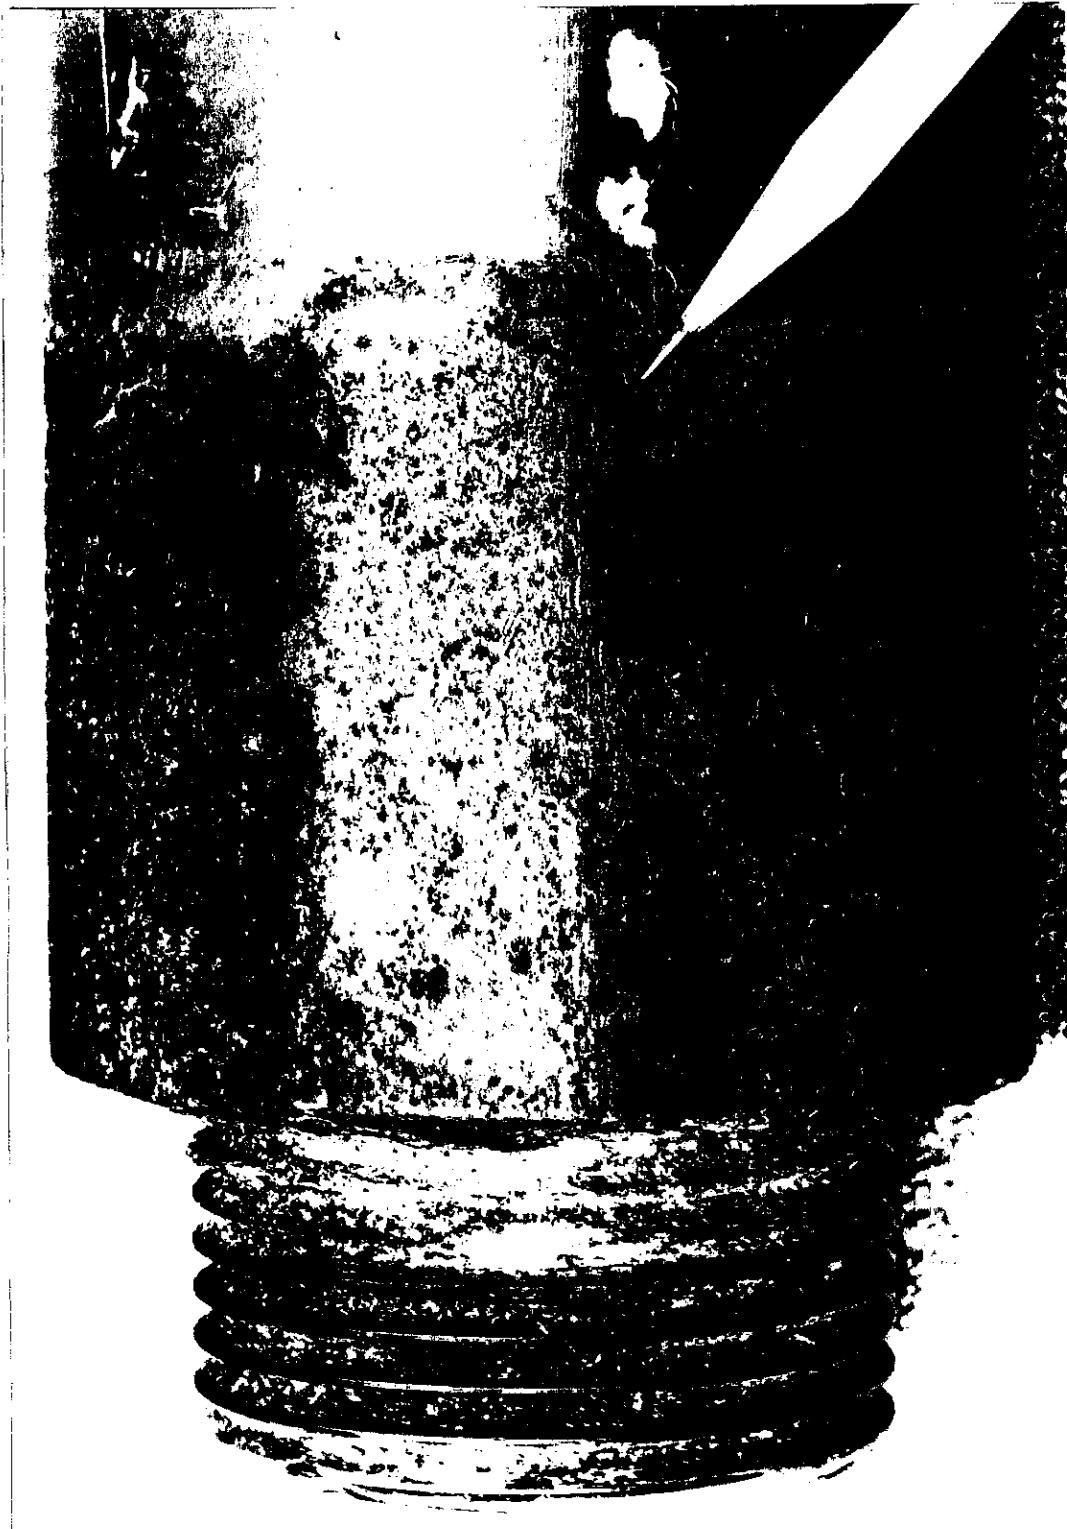
surfaces of the pin and the supporting saddles (Figures 15, 16, 17, and 18). A layer of highly compacted rust was found on the contact surfaces of the pin and the saddles. Parts of the specimens shown in Figure 11, 17 and 18 were submerged in a rust dissolvent. The solution used reacts only with rust and does not attack sound metal. Over 95 percent of the material that was removed had dissolved in the solution. It was concluded that the seizure of the bearing was directly related to the accumulation of rust that had formed on these surfaces.

Visual inspection of the exposed surface areas of the above specimens that were cleaned with the rust dissolvent did not reveal severe signs of galling as previously observed on the laboratory specimens. The absence of galling indicates that the formation of rust was probably the major factor contributing to the seizure of the bearing.

The pin has a $3\frac{1}{2}$ in. diameter and a clearance of $1/50$ in. with respect to the bored diameter of the pin holes in the assembly. The narrow clearance between the pin and the bored holes may have influenced the short duration of time required for sufficient rust to accumulate and freeze the bearing.

Figure 15. Pin removed from bearing assembly of Poplar Street Complex.

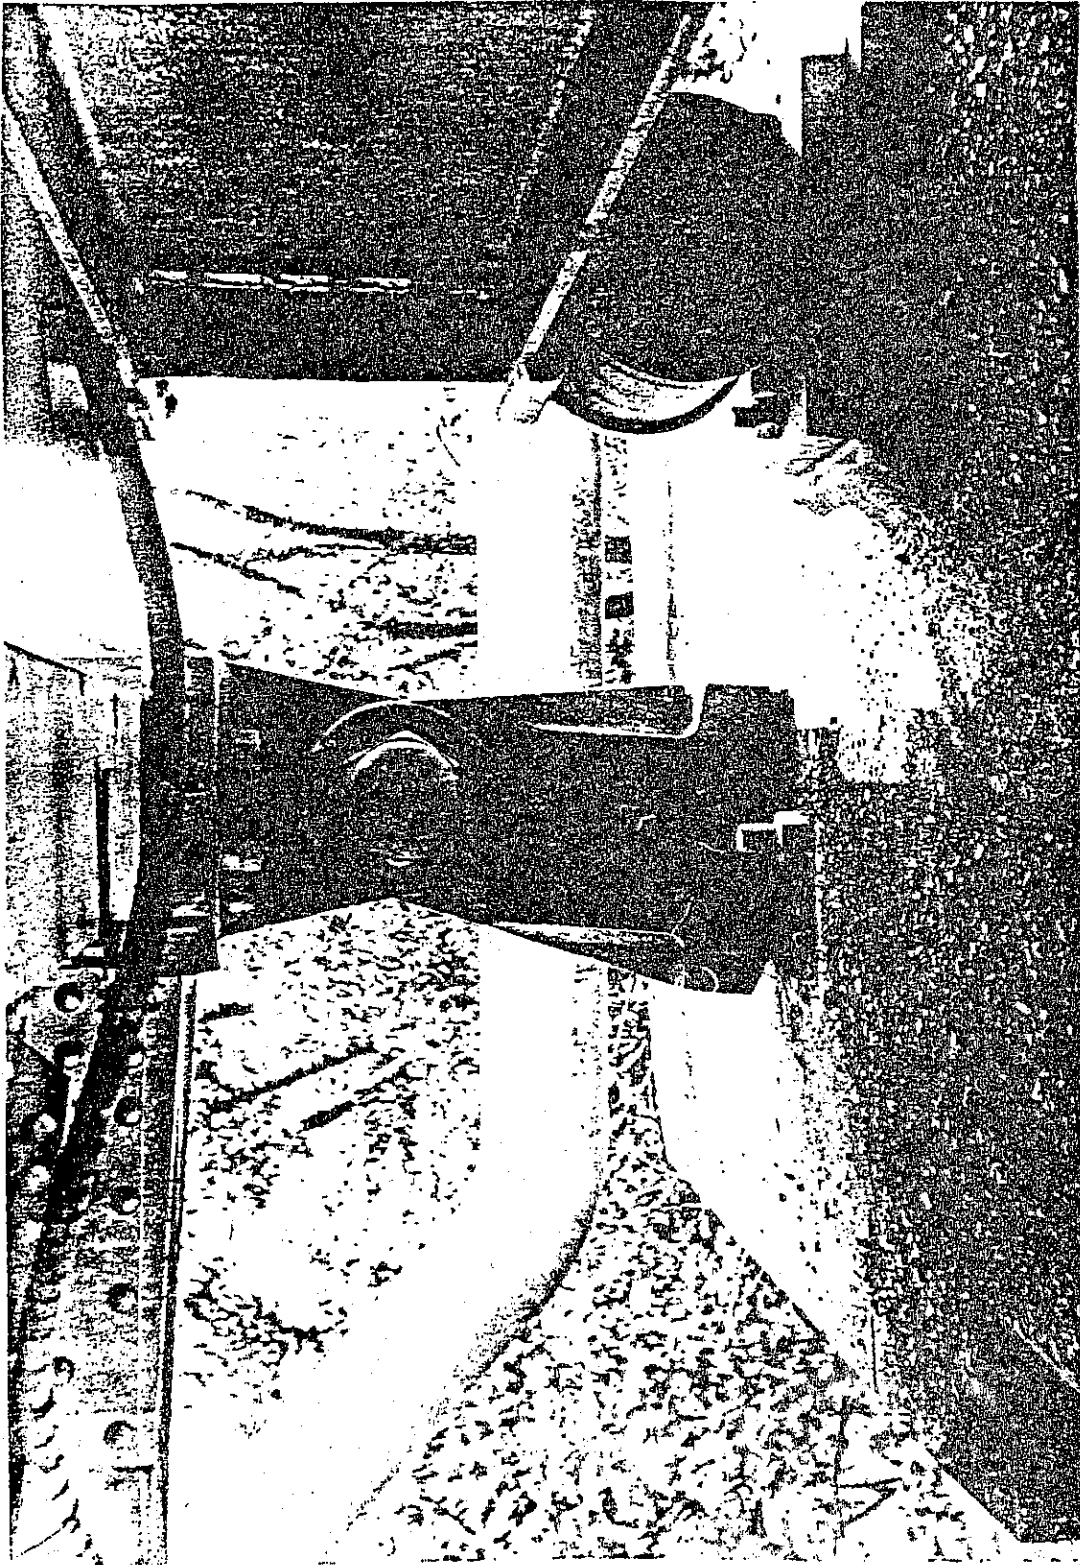
Figure 20. Pin connected bearing assembly from Lacon Bridge.

is identified as the Lacon Bridge over the Illinois River, SBI 90, Section 1-B. Marshall County. The bridge has a design expansion length of 700 ft from the fixed bearing to the location of the pin-connected expansion bearing. A photograph of the bearing assembly is shown in Figure 20.

The assembly was placed in a 300-ton press to determine the load required to rotate the assembly about the pin. The press did not have sufficient capacity to free the pin from the frozen condition. The load was applied longitudinally to the bearing in the direction of normal travel.

The holes in the top and bottom bolsters were rebored and a new pin was fabricated for the assembly. The housing was equipped with grease fittings and the pin was case hardened to alleviate the effect of galling. Recessed grooves were also machined into the pin in line with the grease inserts to provide a means of dispersing the grease around the pin. This procedure was suggested on the basis of the findings of laboratory tests.

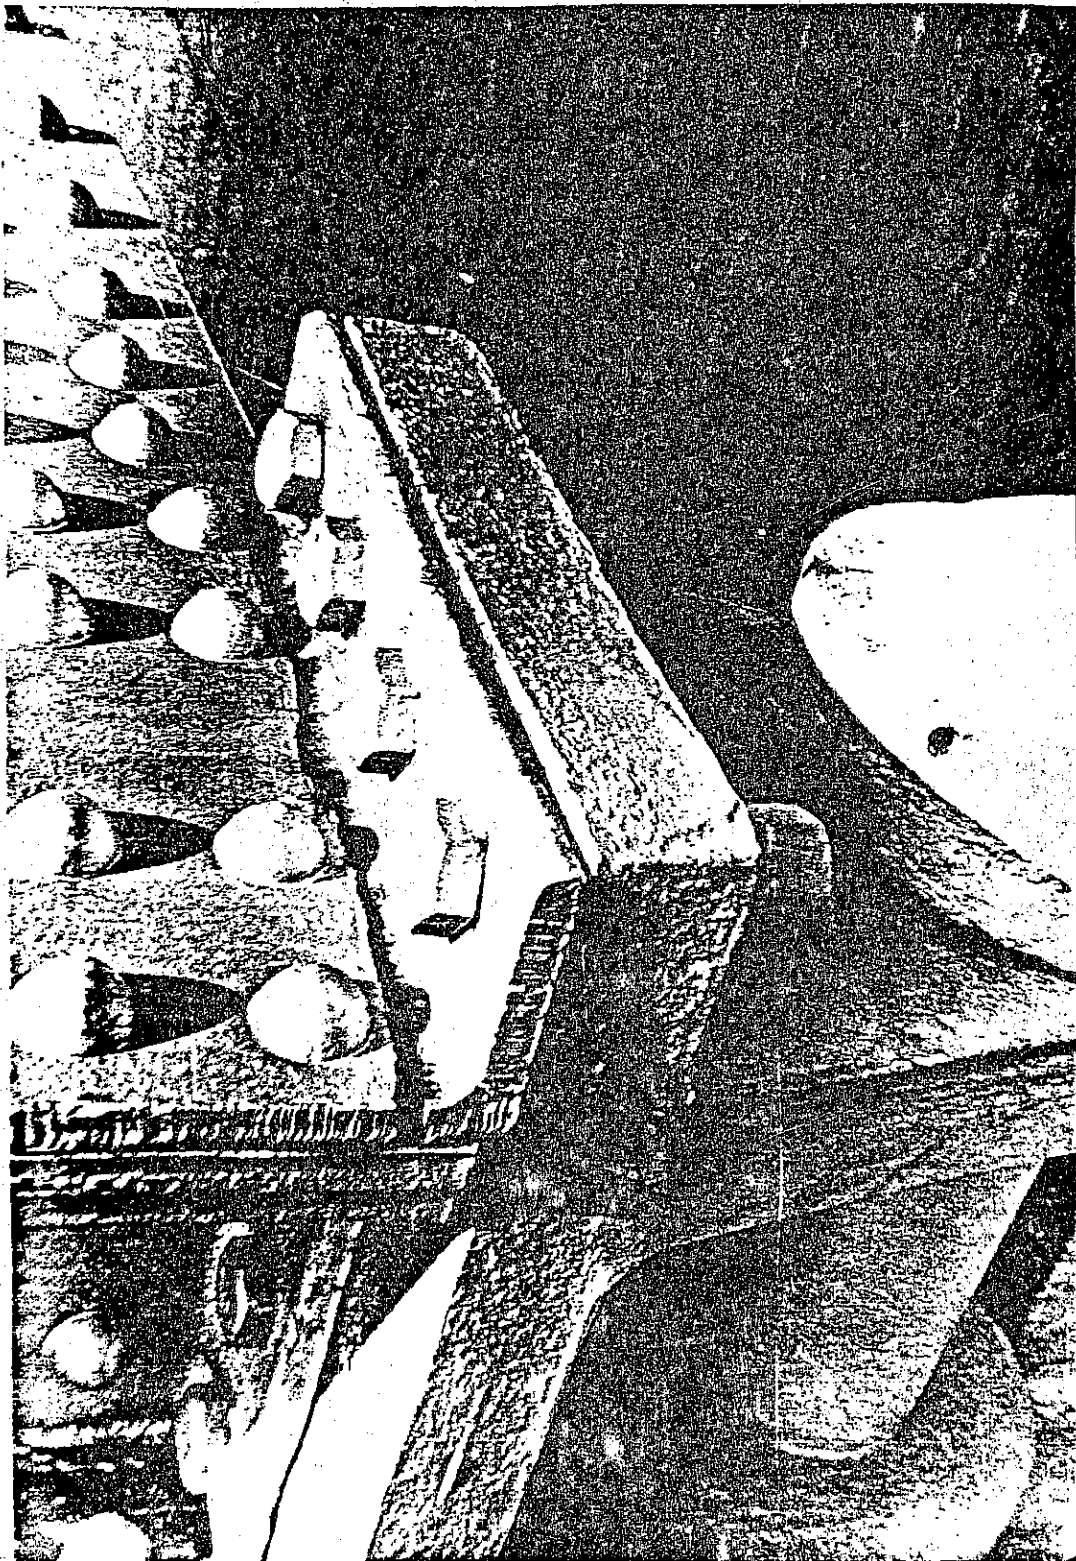
Seizure of the bearing had become apparent during an inspection in the fall of 1971. Signs of localized distress were found which were directly attributed to the seized bearings (Figure 21). The bearing assemblies supporting the truss have steel clip angles connecting the top bolster of the assembly to the lower chord of the truss. An exceptionally wide crack had formed completely through the clip angle as shown on Figure 21.

Figure 21. Localized distress found on clip angle of Lacon Bridge.

Unsuccessful attempts to free the bearing in place were made by the State maintenance forces of the Bureau of Maintenance. Penetrating oils were applied and an attempt was made to force grease into the contact areas through holes drilled into the housing. Since the bearing could not be freed in place, a decision was made to remove the bearing assembly so that it could be restored to a working condition.
